TOWN OF CASTINE, MAINE WATER SUPPLY CHALLENGES AND SOLUTIONS

CLIMATE & WEATHER INFORMATION FOR NEW ENGLAND WATER
UTILITIES & STORMWATER MANAGERS

BY: ANNALEIS HAFFORD P.E., VICE PRESIDENT, OLVER ASSOCIATES INC.

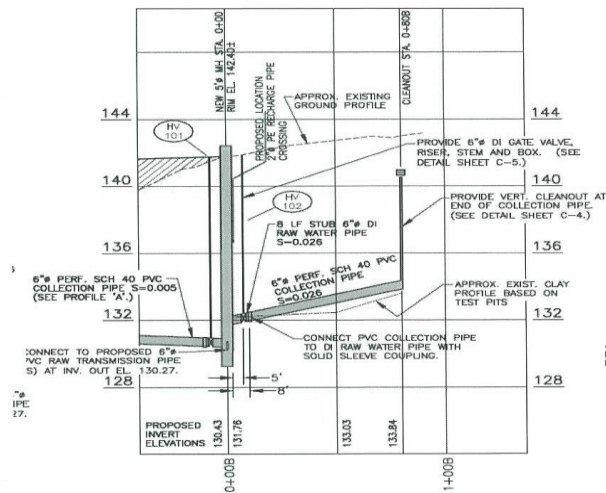
PROFILE SHOWING HORIZONTAL WELL'S CONNECTION TO COLLECTION MANHOLE

The manhole

- THE CONSTRUCTION OF THIS SYSTEM WAS DONE IN TWO PROJECT PHASES :
 - THE PROJECT FIRST INCLUDED INSTALLATION OF A NEW 6-INCH HORIZONTAL PRODUCTION WELL INCLUDING A CONCRETE MANHOLE OR COLLECTION STRUCTURE.

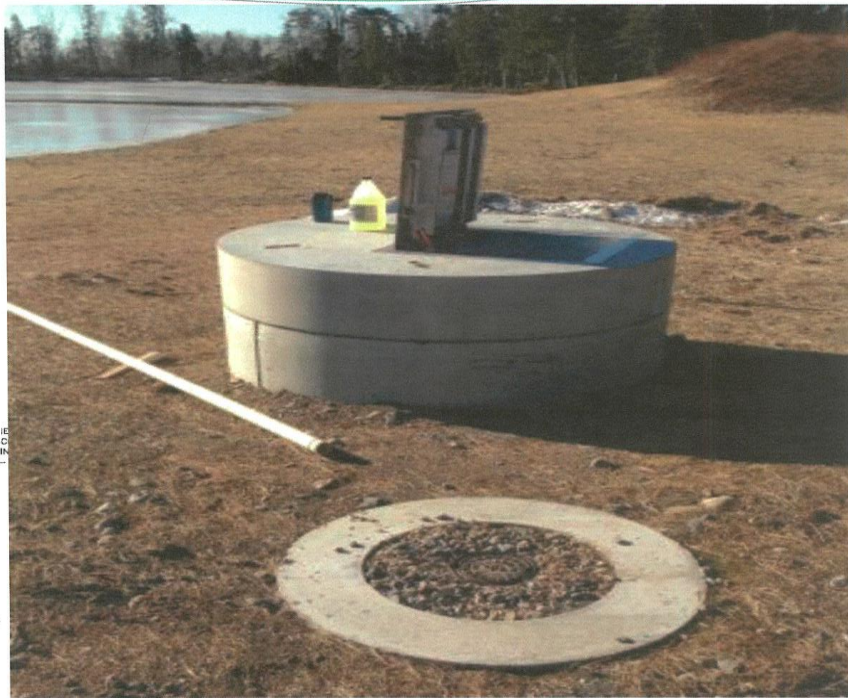
PROFILE B — PROPOSED 6"Ø PERFORATED PVC COLLECTION PIPE (FAST) TO PROPOSED COLLECTION MH

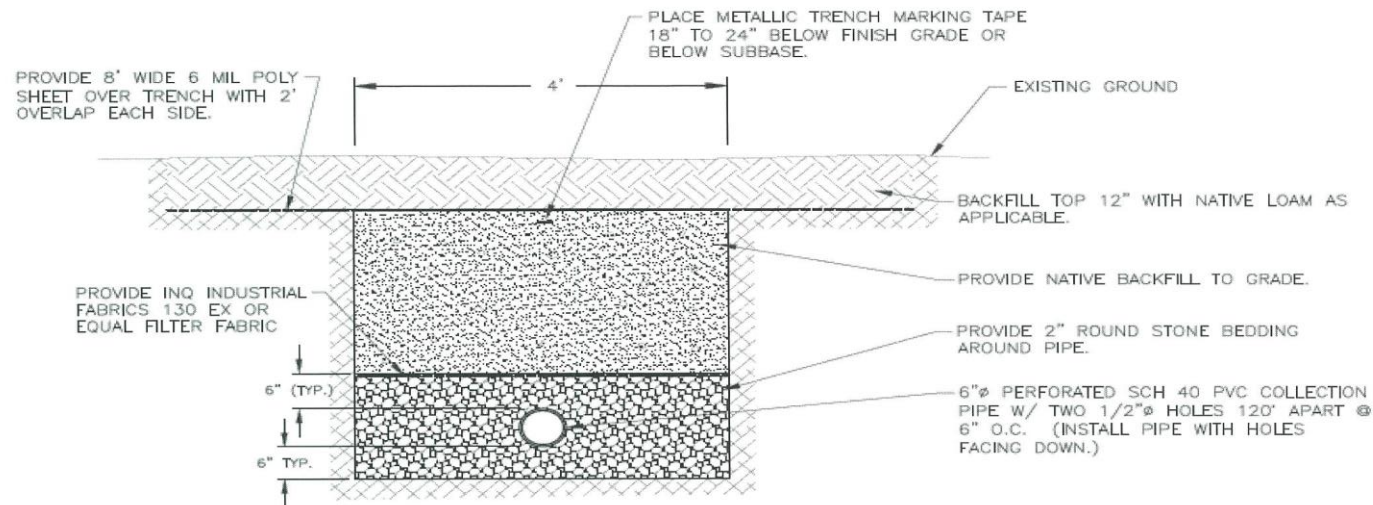
SECTION OF HORIZONTAL WELL INSTALLATION

Production Well Specifications

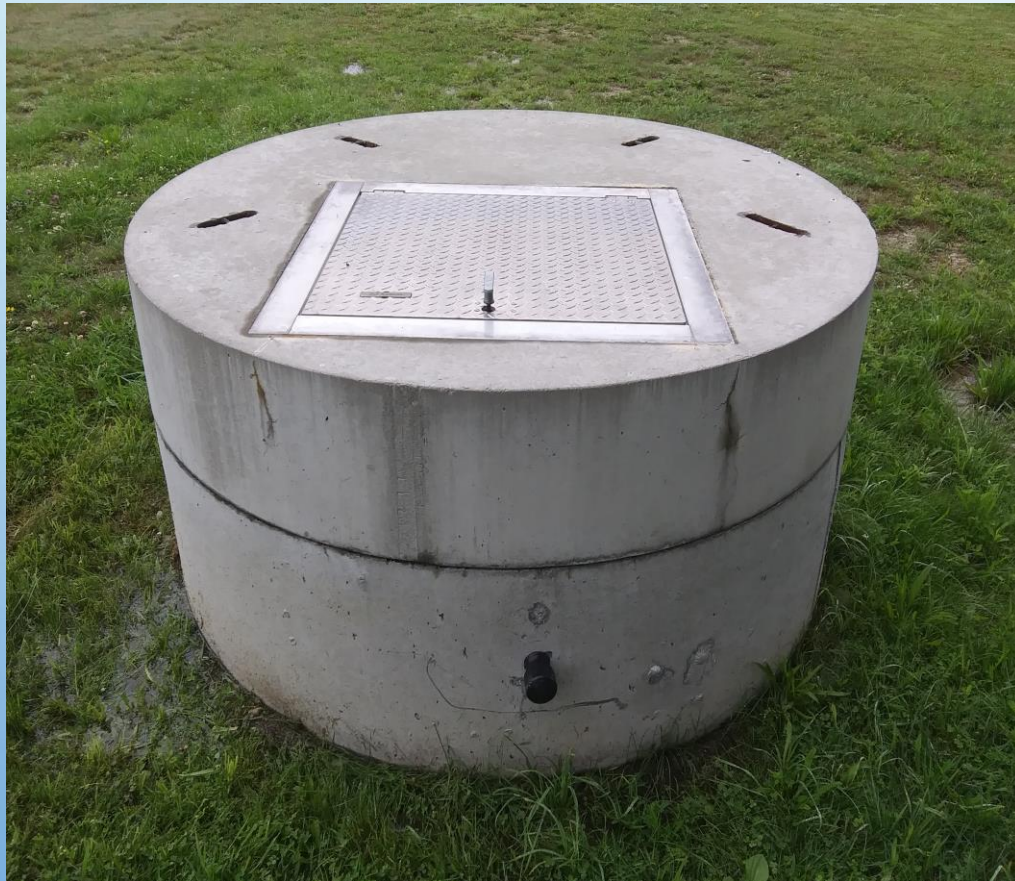
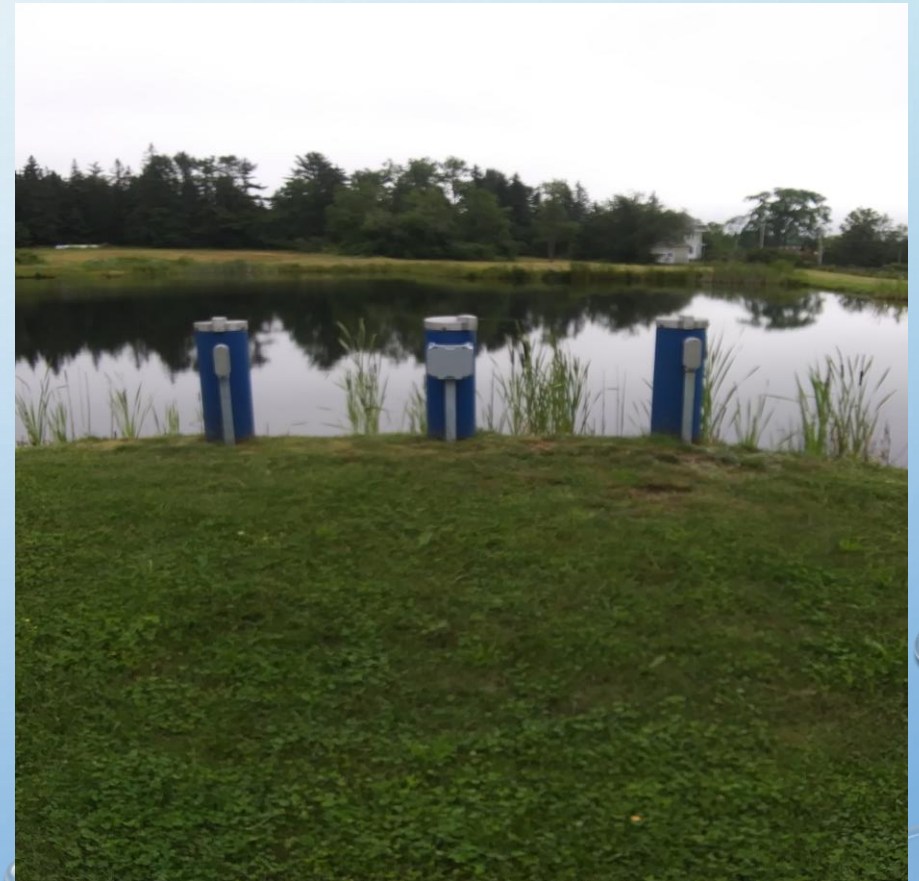
COLLECTION PIPE TRENCH DETAIL

GRAVITY COLLECTION MANHOLE AND DOWNSTREAM WELLS AND TRANSDUCER HOUSING

- GRAVITY PIPING FROM THE COLLECTION STRUCTURE TO TWO WELL CASINGS WITH A CENTER WELL FOR A TRANSDUCER, ALONG WITH A FUTURE FORCEMAIN FOR RECHARGE WERE INSTALLED.

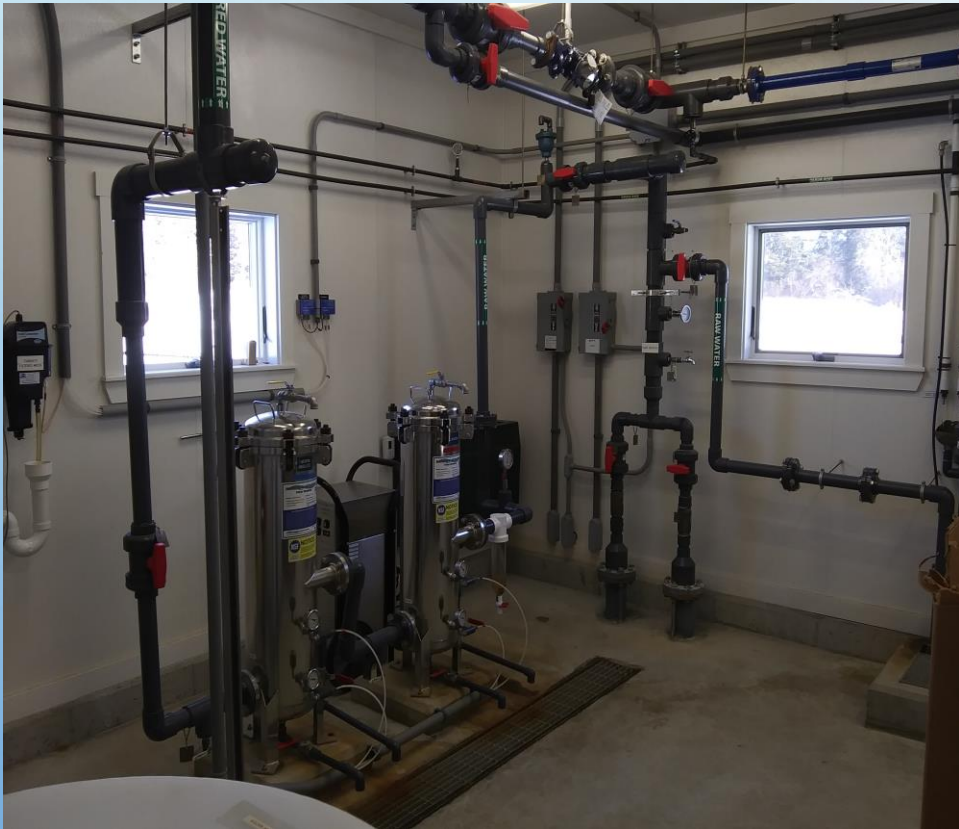
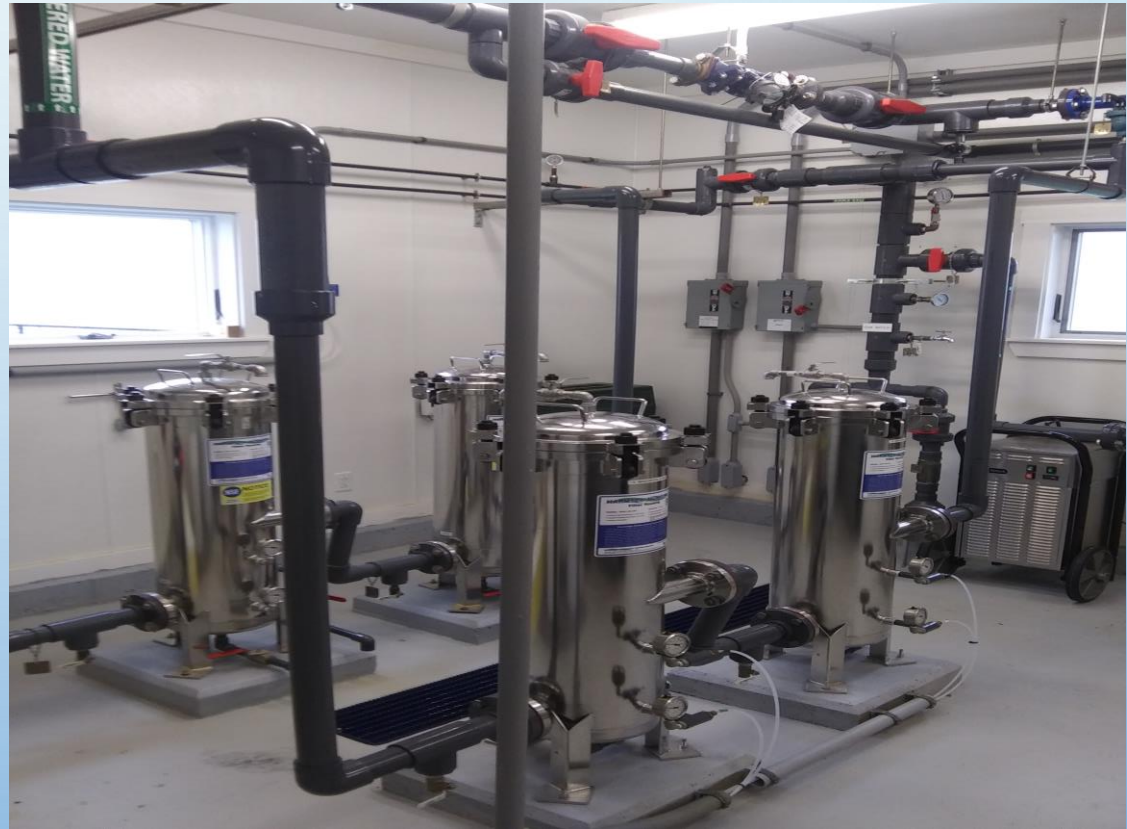
CARTRIDGE SYSTEM SHOWING THE SINGLE TRAIN INITIALLY INSTALLED IN 2016 AND THE SECOND TRAIN INSTALLED IN FEBRUARY, 2020

- FOLLOWING THE INSTALLATION OF THE NEW HORIZONTAL WELL THE OLD TREATMENT SYSTEM WAS DEMOLISHED AND A NEW SYSTEM WAS CONSTRUCTED INCLUDING:
 - ONE TRAIN CARTRIDGE FILTRATION SYSTEM WITH TWO FILTERS (HARMSCO WITH A 1 MICRON FILTER FOLLOWED BY A 1 MICRON ABSOLUTE FILTER)

- SINCE THE ORIGINAL DESIGN WE HAVE MADE THE FOLLOWING IN-HOUSE IMPROVEMENTS:
 - INSTALLED A SECOND WELL PUMP SO WE HAVE BACKUP IF THE ORIGINAL PUMP FAILS.
 - THE NEW SUPERINTENDENT HAS INSTALLED A SECOND TRAIN JUST LIKE THE FIRST TO IMPROVE THROUGHPUT AND IMPROVE IRON CLOGGING. THIS HAS DOUBLED THE PRODUCTION OF THIS SOURCE.
 - OBTAINED APPROVAL FOR ARTIFICIAL RECHARGE OPERATIONS AND WATER SUPERINTENDENT AND STAFF INSTALLED SYSTEM.
 - SHUTDOWN THE LONGER WEST SIDE COLLECTOR WHERE IRON PRESENTED ITSELF AND ARE ONLY USING THE SHORT EAST COLLECTOR.
 - WATER SUPERINTENDENT AND STAFF HAS OPTIMIZED OPERATIONS SO THE SYSTEM IS NOW ABLE TO RUN AUTOMATICALLY WITH NO ISSUES. THERE ARE FAIL SAFE CONTROLS TO SHUT THE SYSTEM DOWN AUTOMATICALLY.

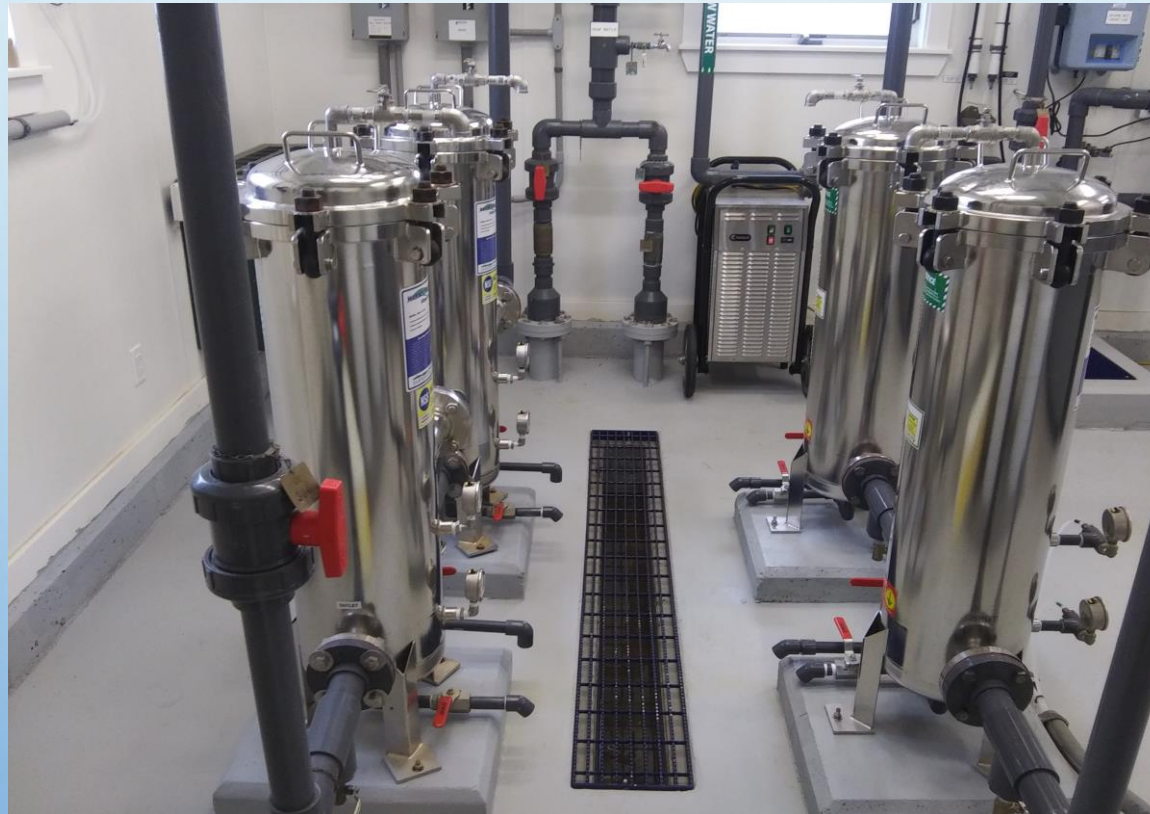
DUAL TRAIN CARTRIDGE FILTRATION SYSTEM

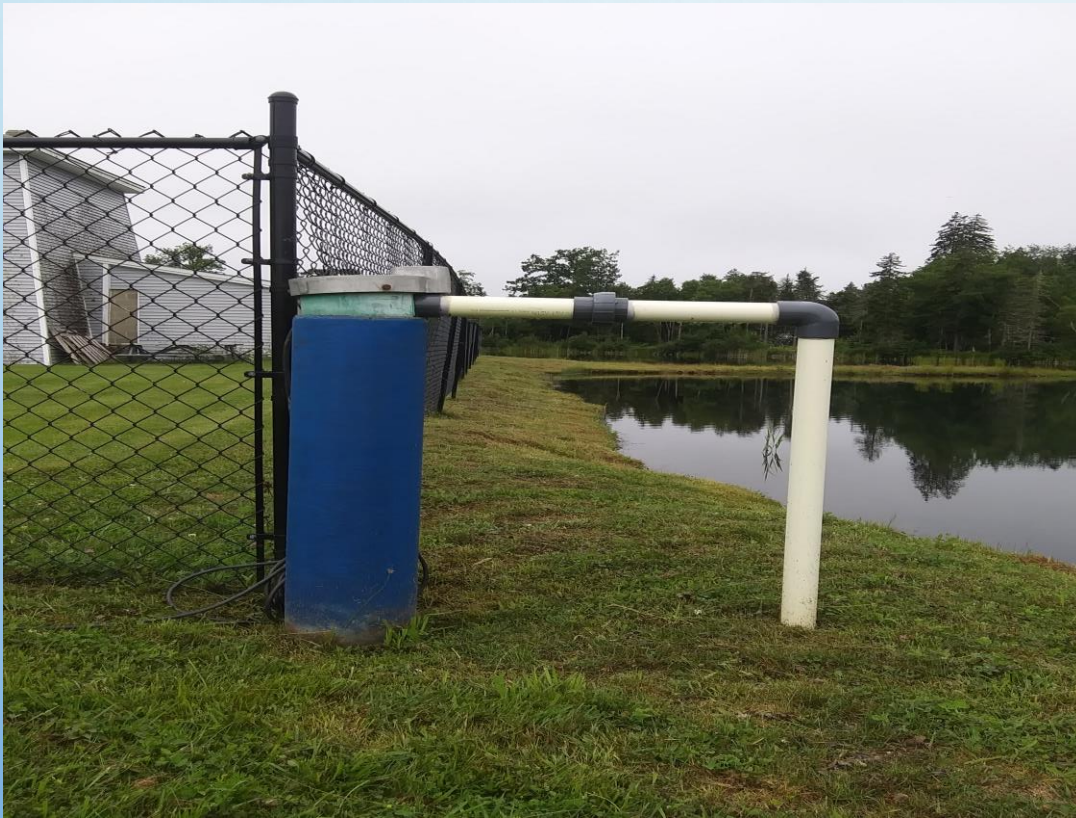
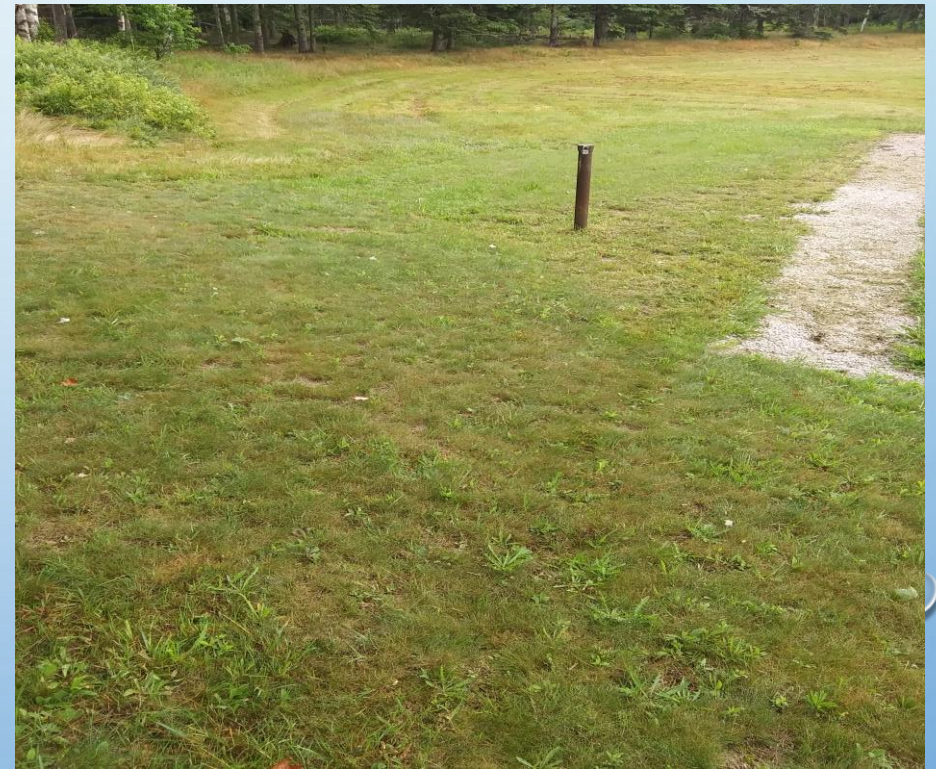
FUTURE STUDIES AND IMPROVEMENTS FOR DROUGHT OPERATIONS – ARTIFICIAL RECHARGE

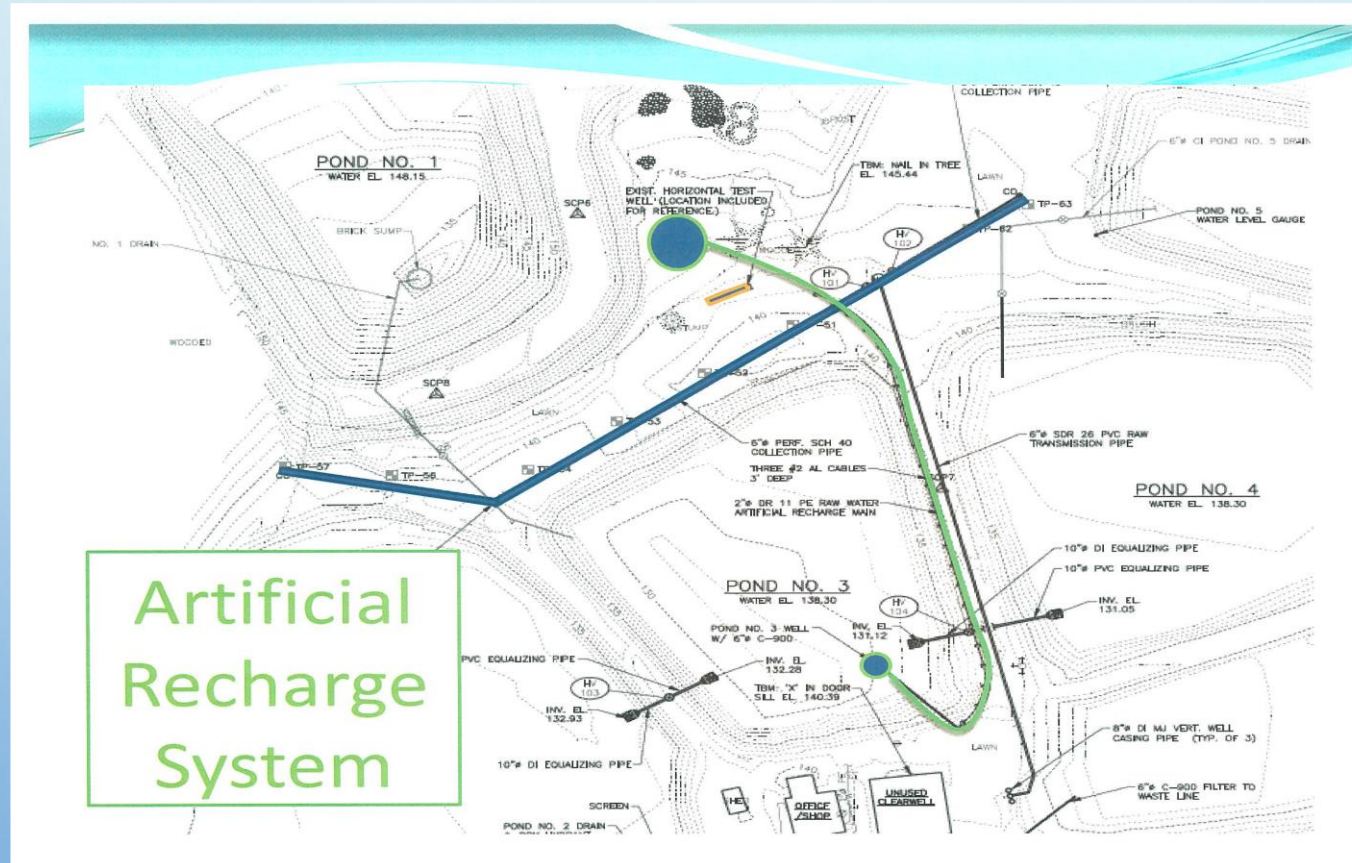
BASIC LAYOUT OF ARTIFICIAL RECHARGE SYSTEM
